NATIONAL TRANSPORTATION SAFETY BOARD

Group Chairman's Factual Report

OPERATIONAL FACTORS

ANC21FA069

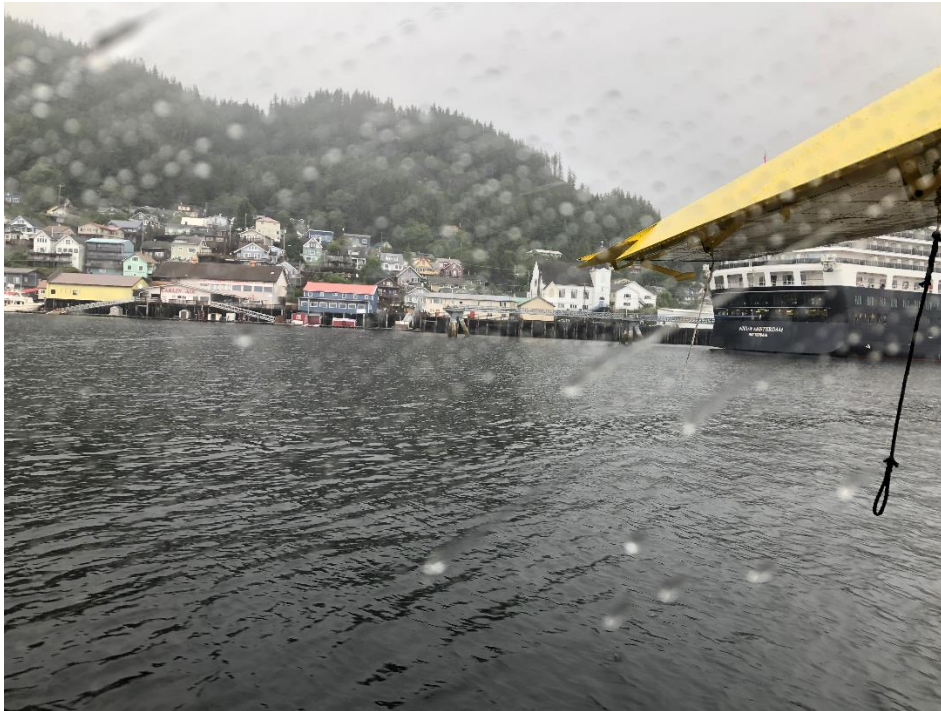
Photo 4: Photo taken by a passenger on the accident flight with an iPhone 8 Plus prior to departure. Photo depicts the left-side view from the accident airplane and shows the MS *Nieuw Amsterdam*, the Ketchikan shoreline, and rain on the passenger window.¹⁹

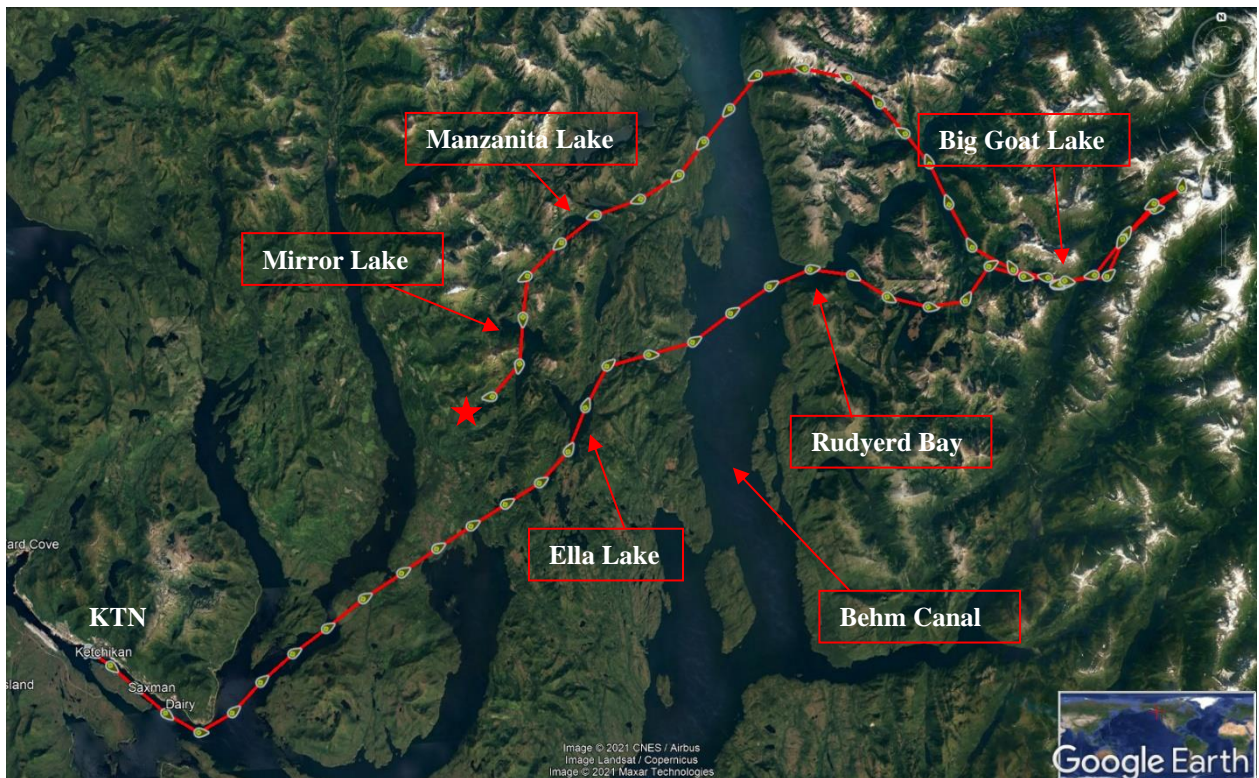
Figure 5: Spidertracks image of N1249K for accident flight on August 5, 2021 (red star indicates approximate location where accident occurred).

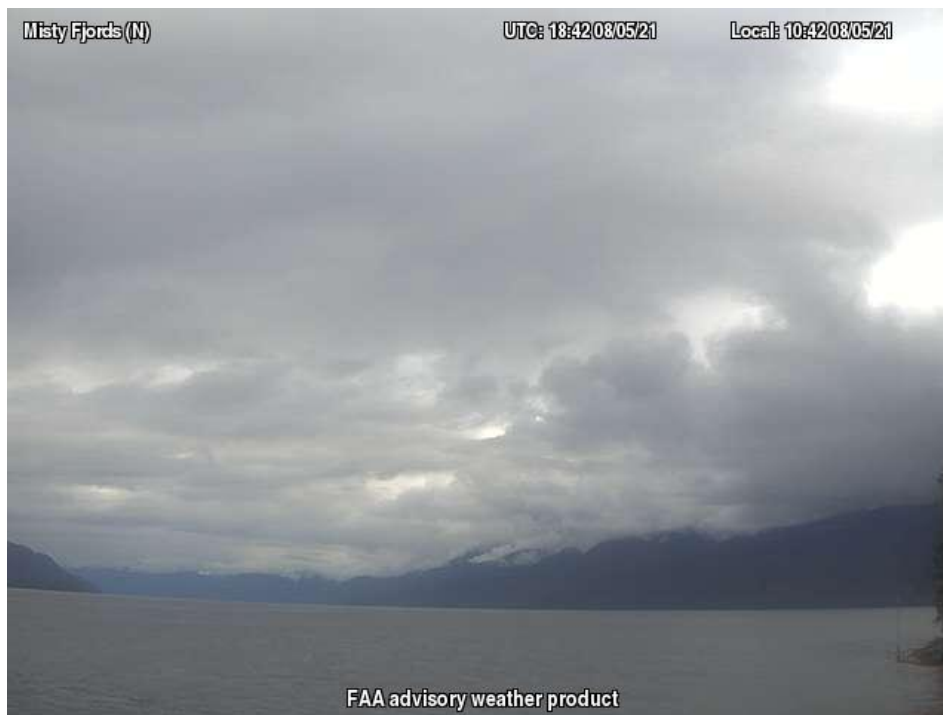
Photo 5: Misty Fjords weather camera looking north up the Behm Canal at 1042.

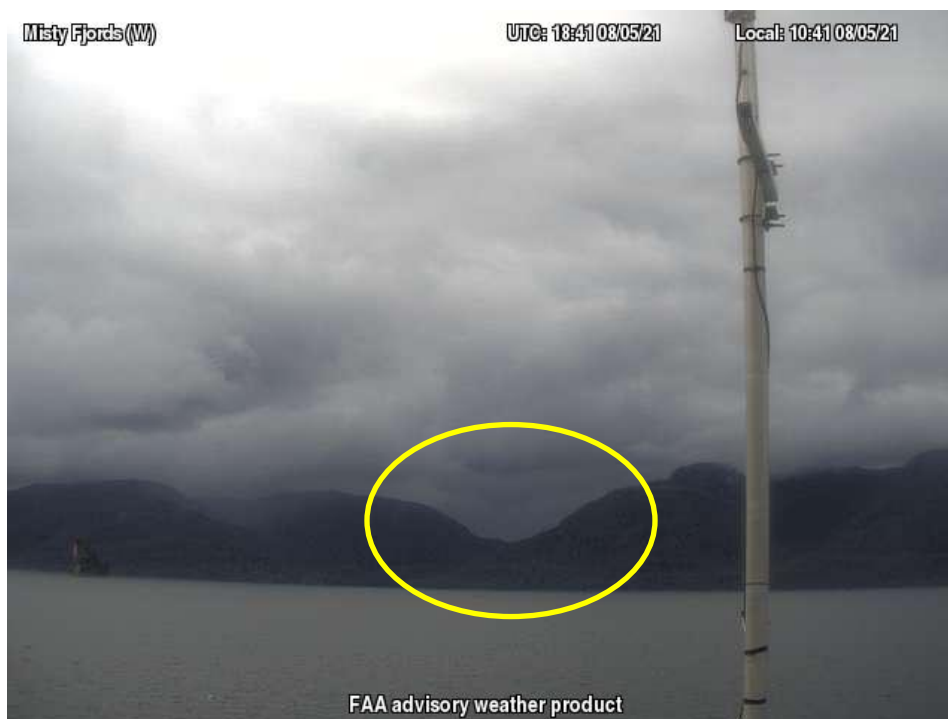
Photo 6: Misty Fjords weather camera looking west toward the Ella Narrows (indicated by yellow circle) at 1041.

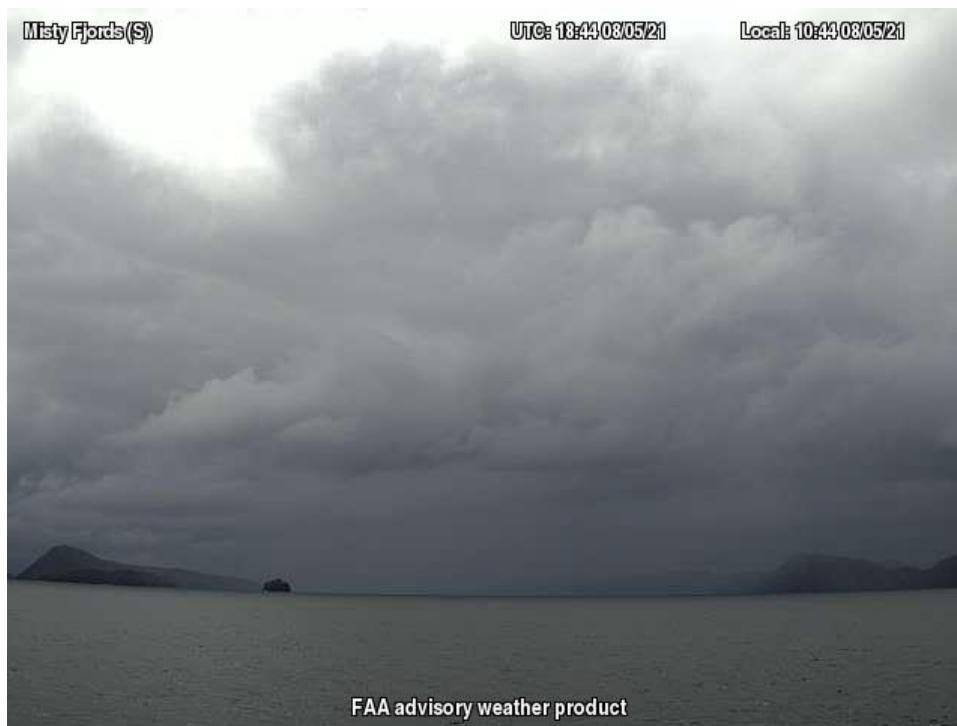
Photo 7: Misty Fjords weather camera looking south down the Behm Canal at 1044.

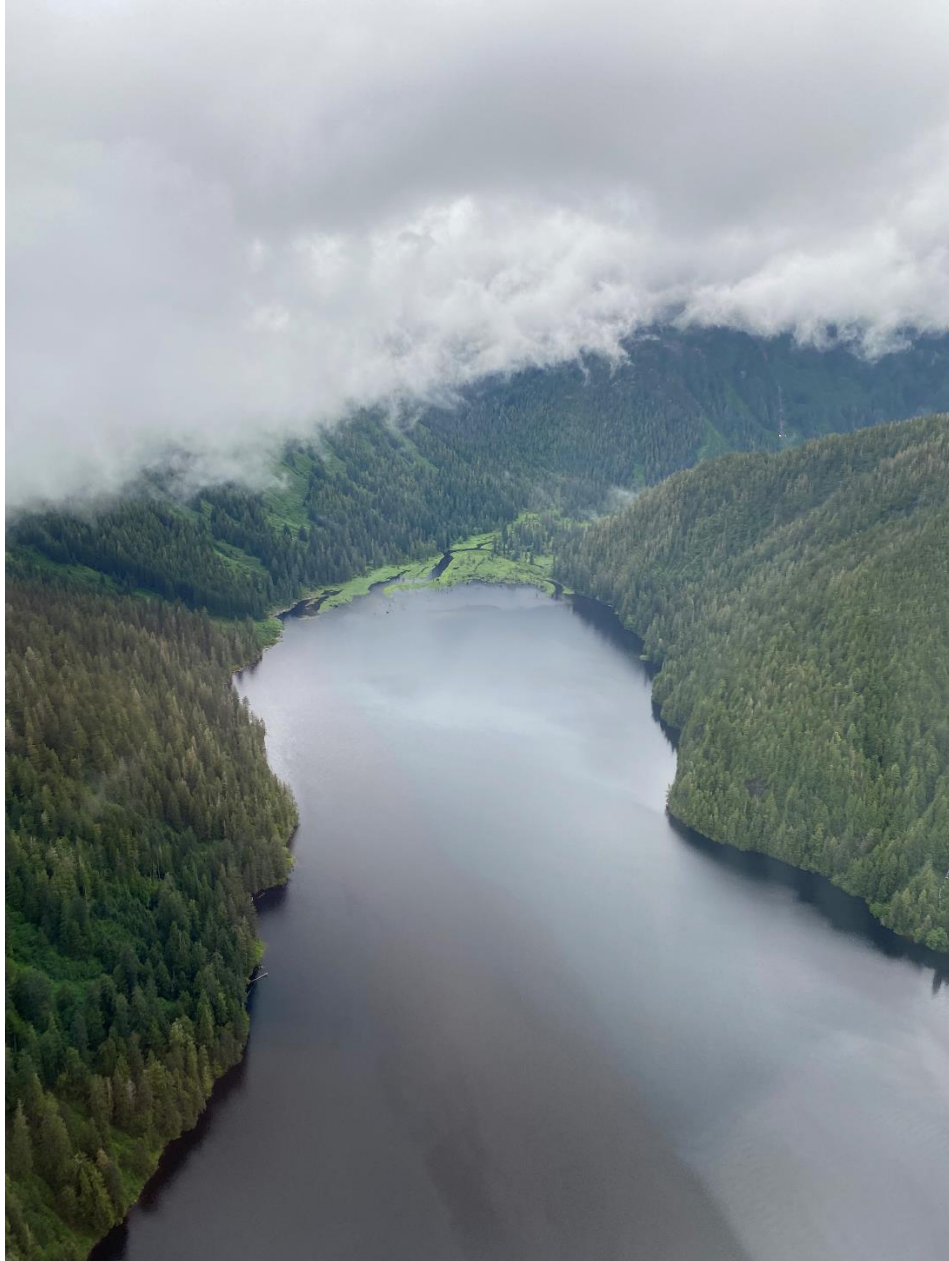
Photo 8: Photo taken from an iPhone 11 recovered at the accident site. Photo was taken at 1047:11 from the right side of the accident airplane and shows the western arm of Mirror Lake looking to the northwest.²¹

²¹ Additional data from this photo indicated that it was taken at a latitude/longitude of 55°31'25.31"N 131° 9'37.50"W at an altitude of 658.2 meters (about 2,159 feet).

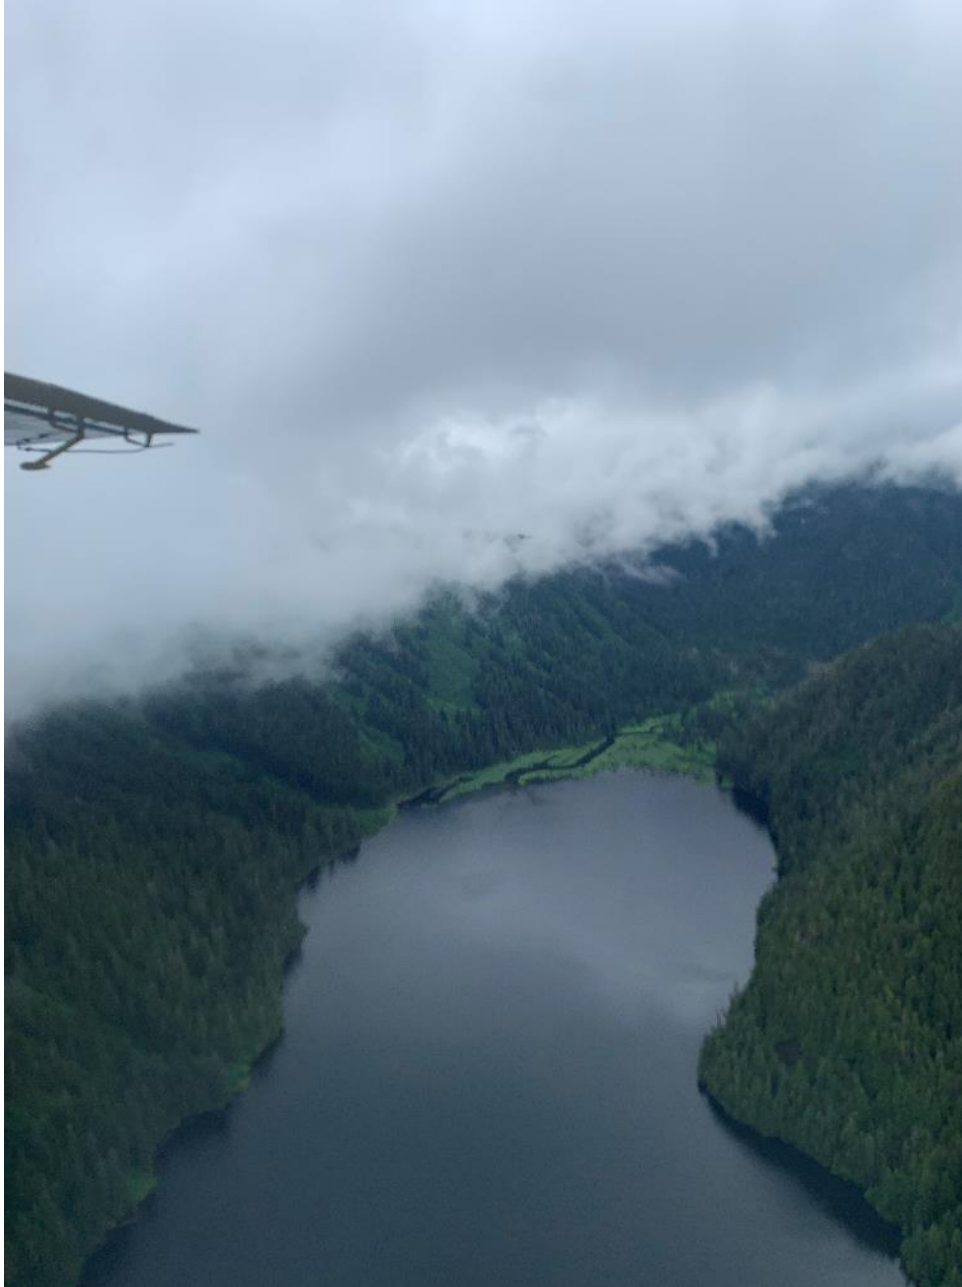
Photo 9: Photo taken from an iPhone XR recovered at the accident site. Photo was taken about 1047 from the right side of the accident airplane and shows the western arm of Mirror Lake looking to the northwest.

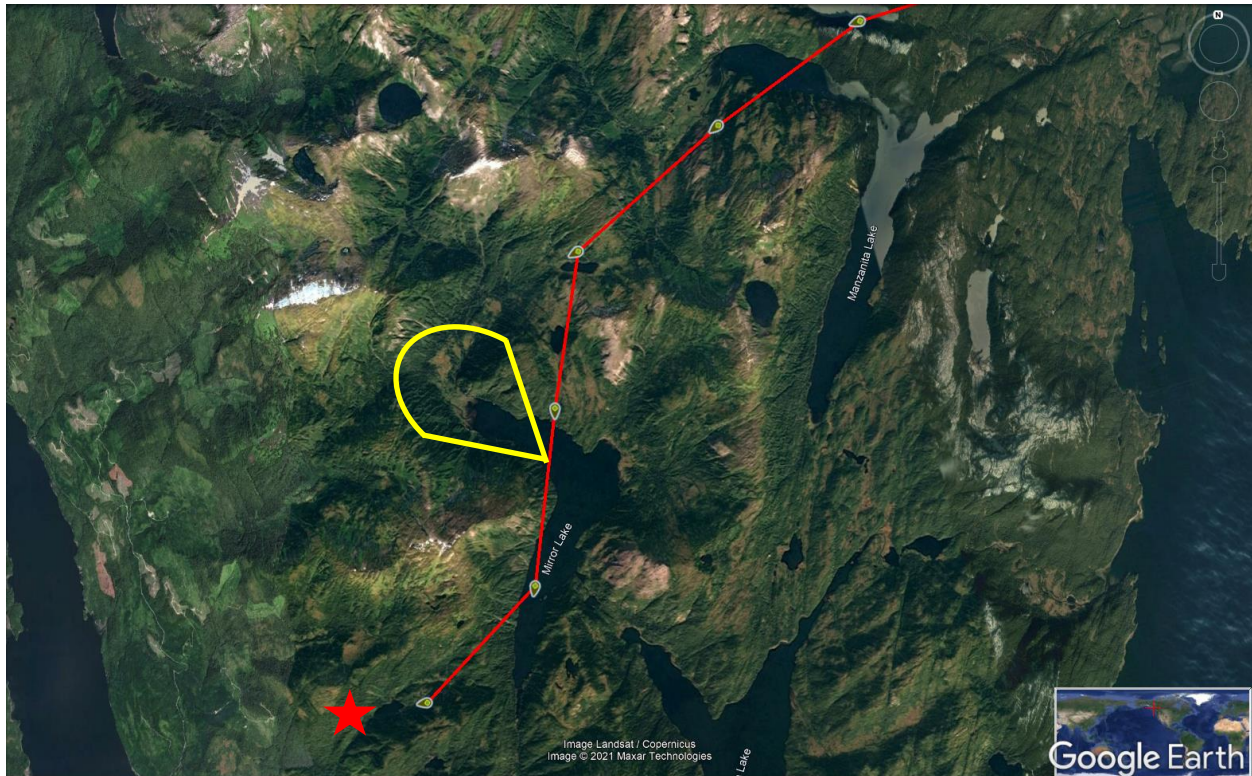
Figure 6: Enlarged Spidertracks view of last portion of accident flight (red star indicates approximate location where accident occurred). Yellow lines depict the approximate view of the iPhone 11 and iPhone XR photos taken about 1047.
